Report on the investigation of  
the grounding of

***Antari***

Near Larne, Northern Ireland

**Report No 7/2009**  
**February 2009**

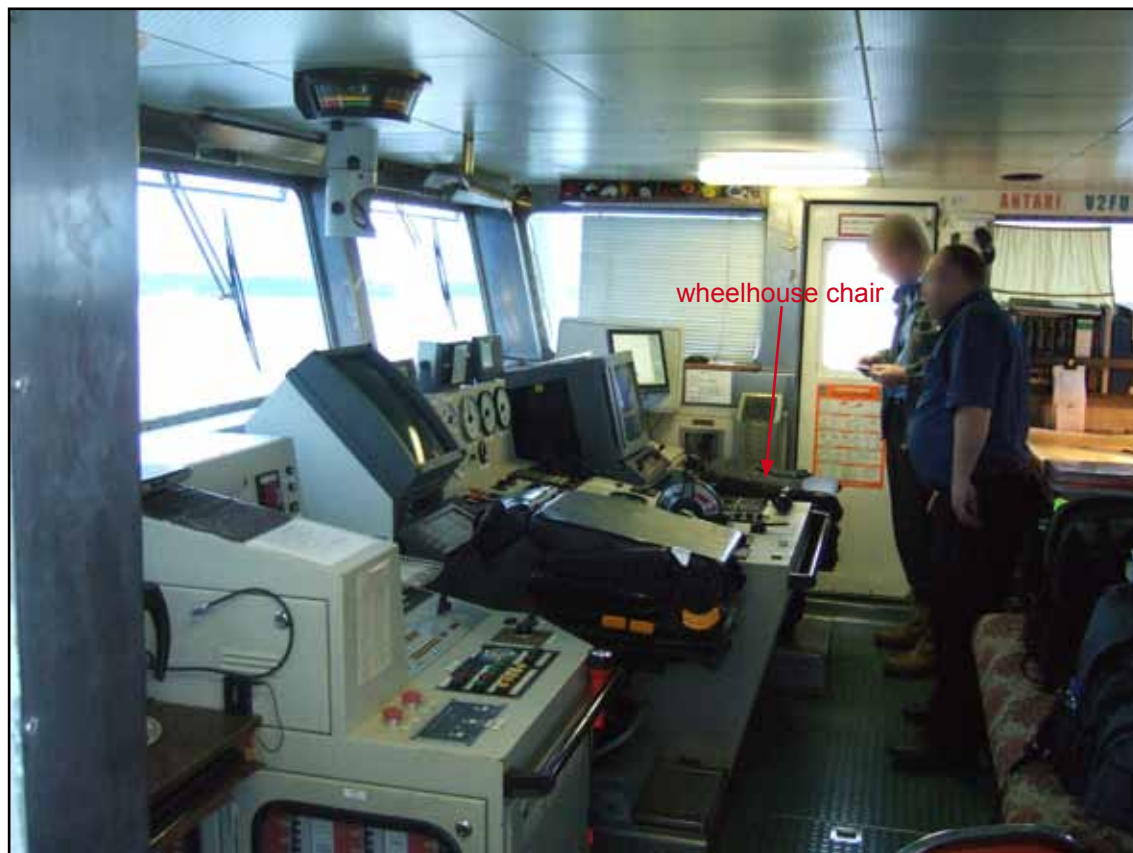
The chief officer was now the sole bridge watchkeeper. Both wheelhouse doors were closed, it was a clear, moonless night and the sea was calm with a slight westerly swell. He was sitting, as was his custom, in a chair on the starboard side of the wheelhouse, in front of one of the radar sets and the ECDIS unit (**Figure 2**). He fell asleep shortly after sitting down, and remained asleep until the vessel grounded at 0321.

*Antari*, wheelhouse chair in which chief officer fell asleep

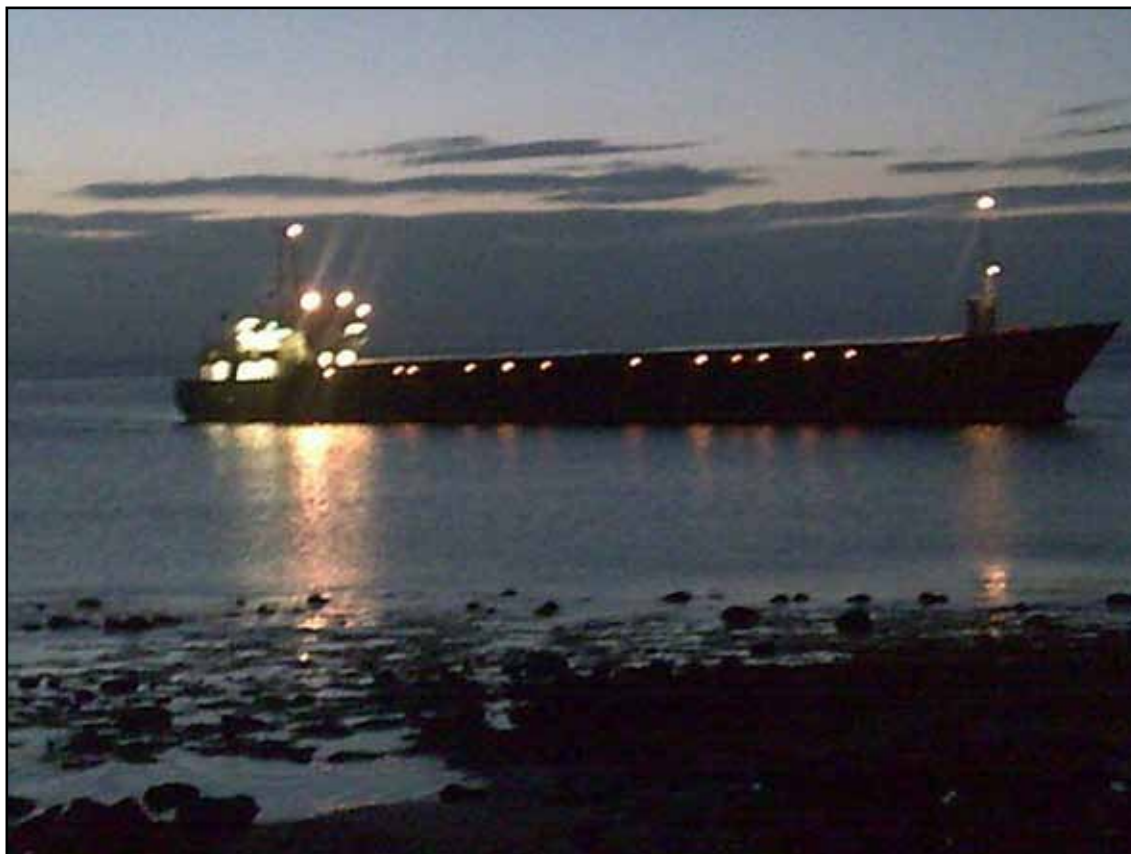
At 0407 a motorist driving along the coast road between Larne and Glenarm reported to Belfast coastguard that he could see a vessel aground on the beach, close to the road at St Drumnagreagh Port (**Figure 3**).

*Antari* aground on the Antrim coast

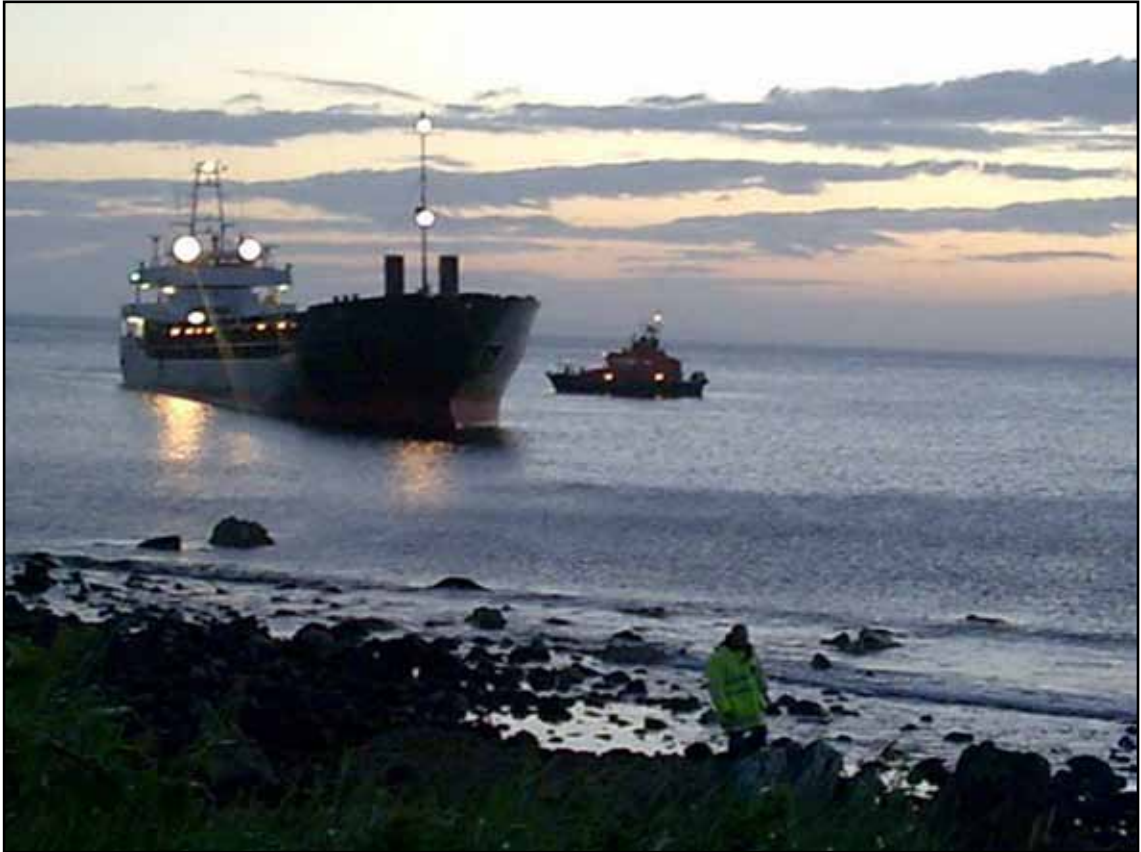
The Larne lifeboat arrived at 0512 and carried out a check, by searchlight, of the vessel for damage and pollution (**Figure 4**).

Larne lifeboat checks *Antari*'s hull for damage

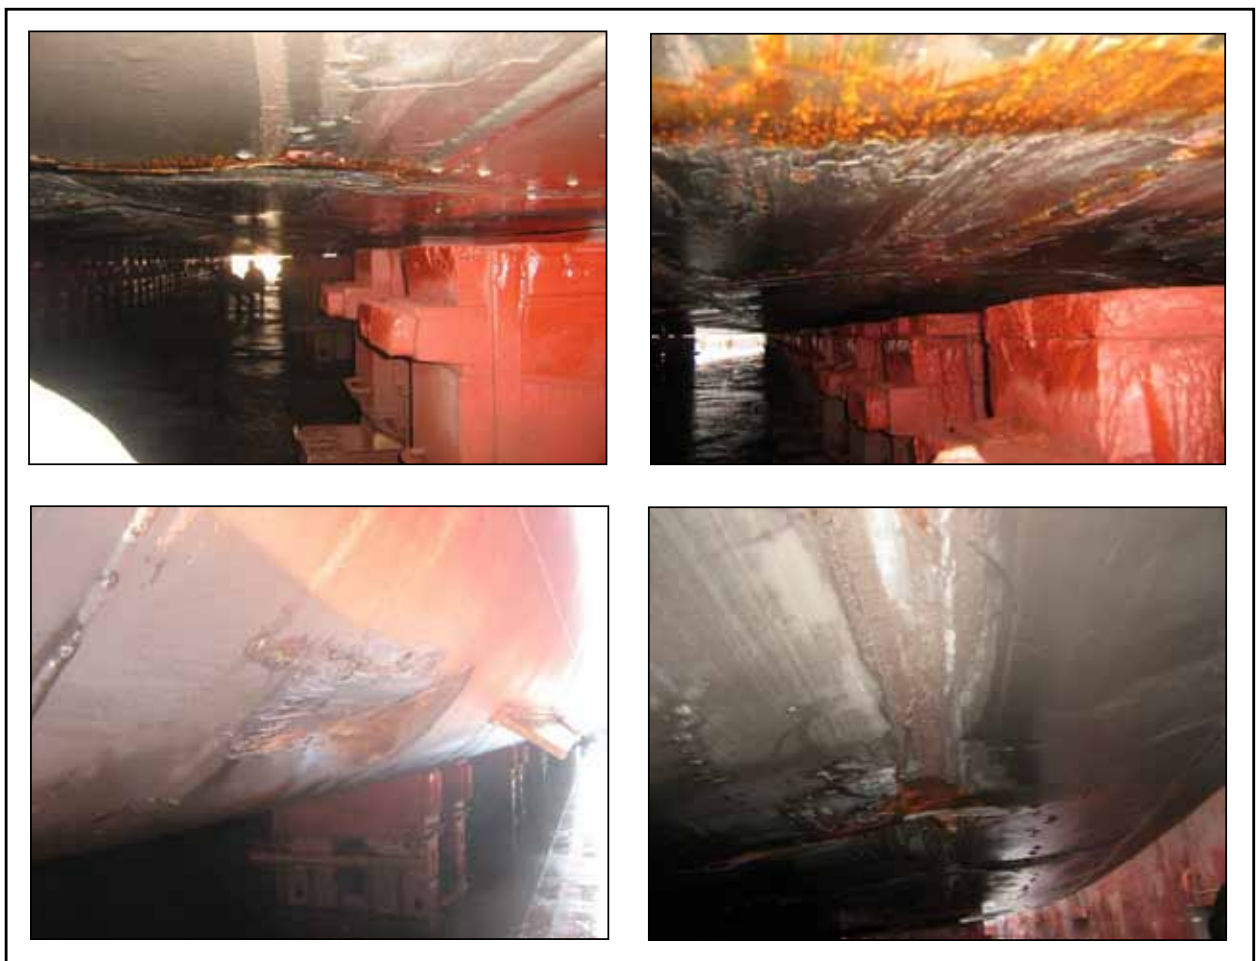
Figure 5

The results of the survey showed indentation damage to the bottom of the hull over 70% of the vessel's length from forward, and found that there was a small hole in number 3 double bottom ballast tank.

Damage to bottom

The vessel departed for Ghent later that day, where she arrived on 3 July. On completion of discharge of the cargo, she proceeded to Swinoujscie, Poland where permanent repairs, lasting several weeks and requiring 25 tonnes of new steelwork to the vessel's bottom (**Figure 5**), were carried out before she was able to resume service.

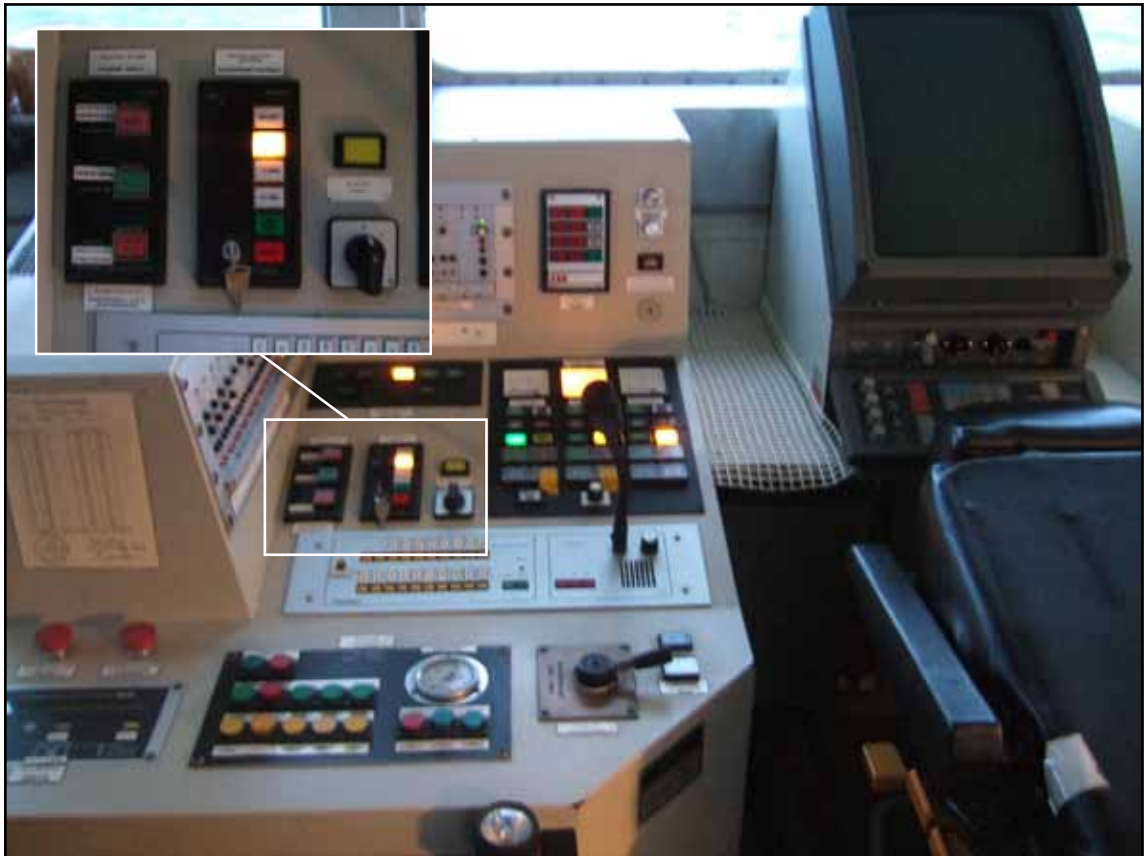
Figure 6

Watch alarm in wheelhouse

However, the audits carried out on *Antari* failed to identify that the watch alarm was not being used or that lookouts were not being routinely posted.

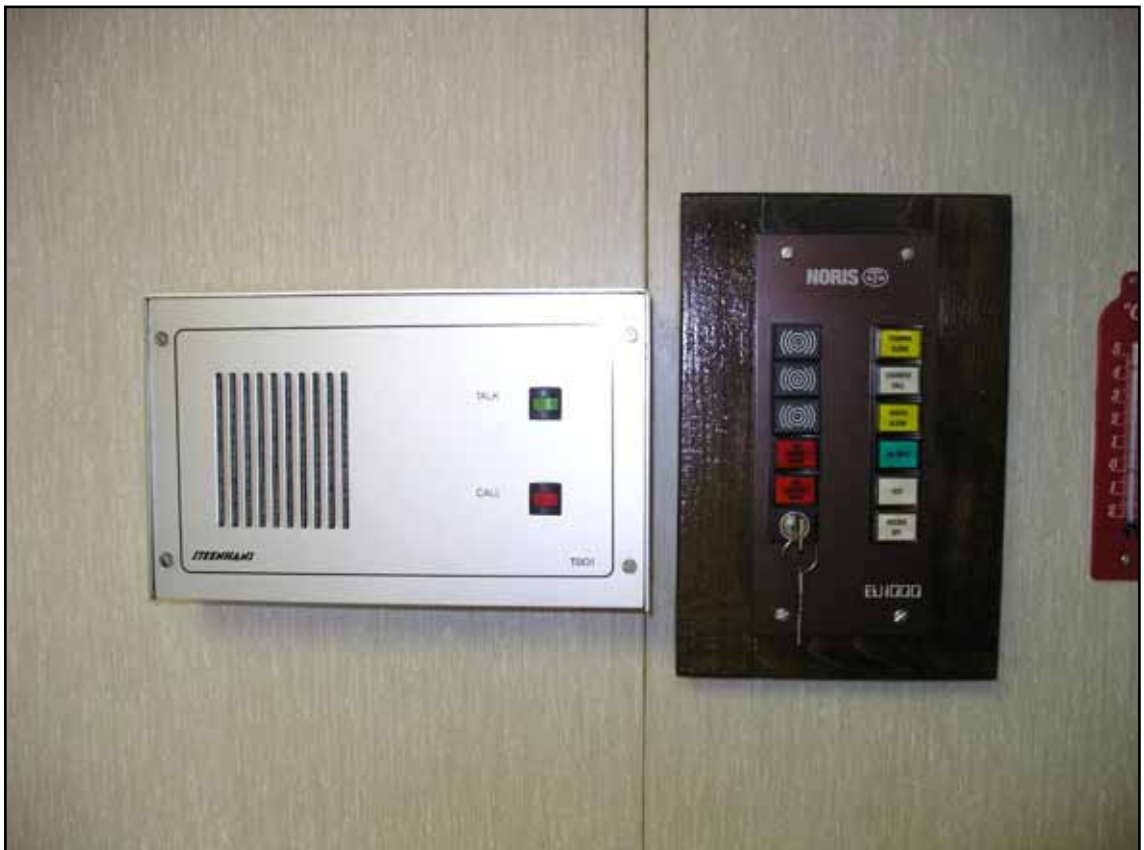
Figure 7

Watch alarm repeater in master's cabin
