Report on the investigation of  
the grounding of

***Antari***

Near Larne, Northern Ireland

**Report No 7/2009**  
**February 2009**

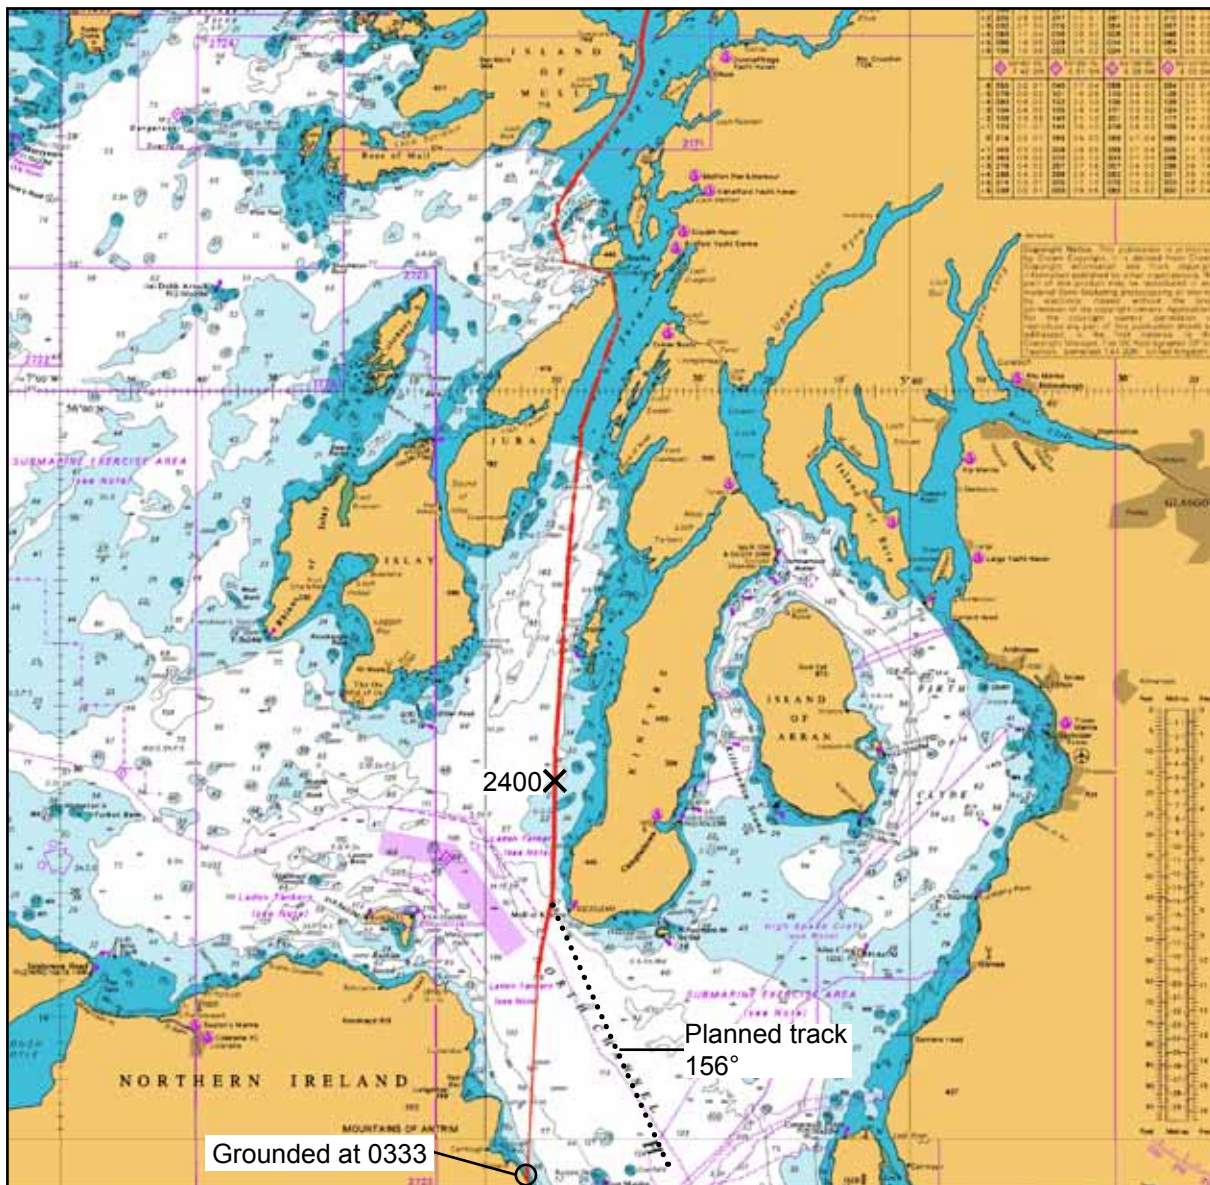
At 2000, with the master as the sole bridge watchkeeper, *Antari* transited the Gulf of Corryvreckan before heading south to run parallel with the west coast of the Kintyre peninsula (**Figure 1**).

BA Chart 2724, extract showing *Antari's* AIS track
